Applicability

This document applies to the part numbers of STM32F070x6/xB devices listed in [Table 1](#) and their variants shown in [Table 2](#).

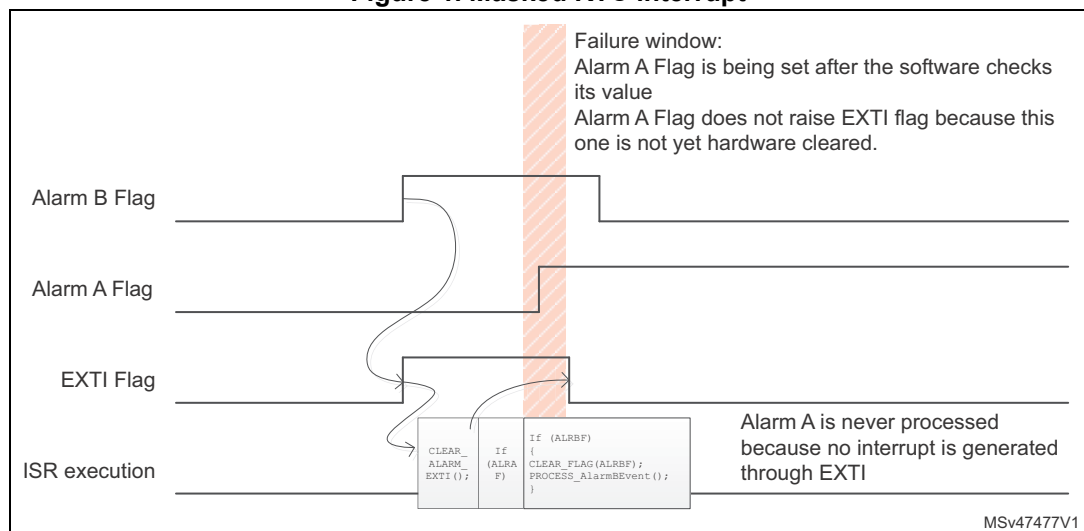
Figure 1. Masked RTC interrupt

One RTC interrupt can mask another RTC interrupt if both share the same EXTI configurable line, such as the RTC Alarm A and Alarm B, of which the event flags are OR-ed to the same EXTI line (refer to the **EXTI line connections** table in the **Extended interrupt and event controller (EXTI)** section of the reference manual).

The following code example and figure illustrate the failure mechanism: The Alarm A event is lost (fails to generate interrupt) as it occurs in the failure window, that is, after checking the Alarm A event flag but before the effective clear of the EXTI interrupt flag by hardware. The effective clear of the EXTI interrupt flag is delayed with respect to the software instruction to clear it.

In the interrupt service routine, apply three consecutive event flag checks - source one, source two, and source one again, as in the following code example:
